Root Cause Failure Analysis – RCFA 1078 – R17 Suspensin Failure Batch #554 (5354)

PURPOSE: Determine why suspension was lost for batch 554 of 5354 on reactor 17

DATE OF RCFA: 12/13/12

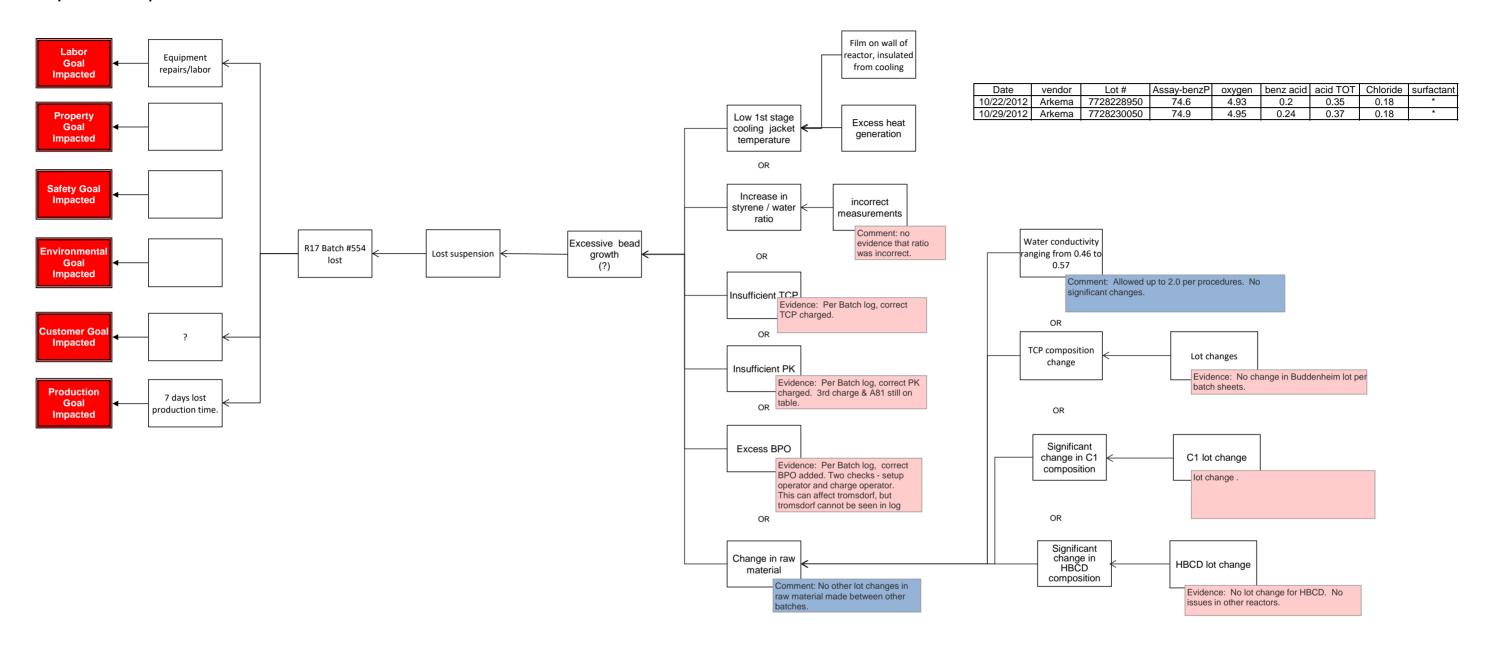
Step 2. Cause Map

ROOT CAUSE: • Unknown

CORRECTIVE ACTIONS	RESPONSIBLE PERSON	DUE	DONE
1) Consider modifying batch sheets or creating a form for operators to document additional actions taken (extra samples, etc) when there are batch issues.	Chad Holman	3/31/13	
2)			
3)			
A TTENDEEC
